MISCELLANEOUS PAPER SL-86-5

EXPLOSIVE TESTS ON REINFORCED CONCRETE WALLS AT CAMP SHELBY, MISSISSIPPI

Final Report

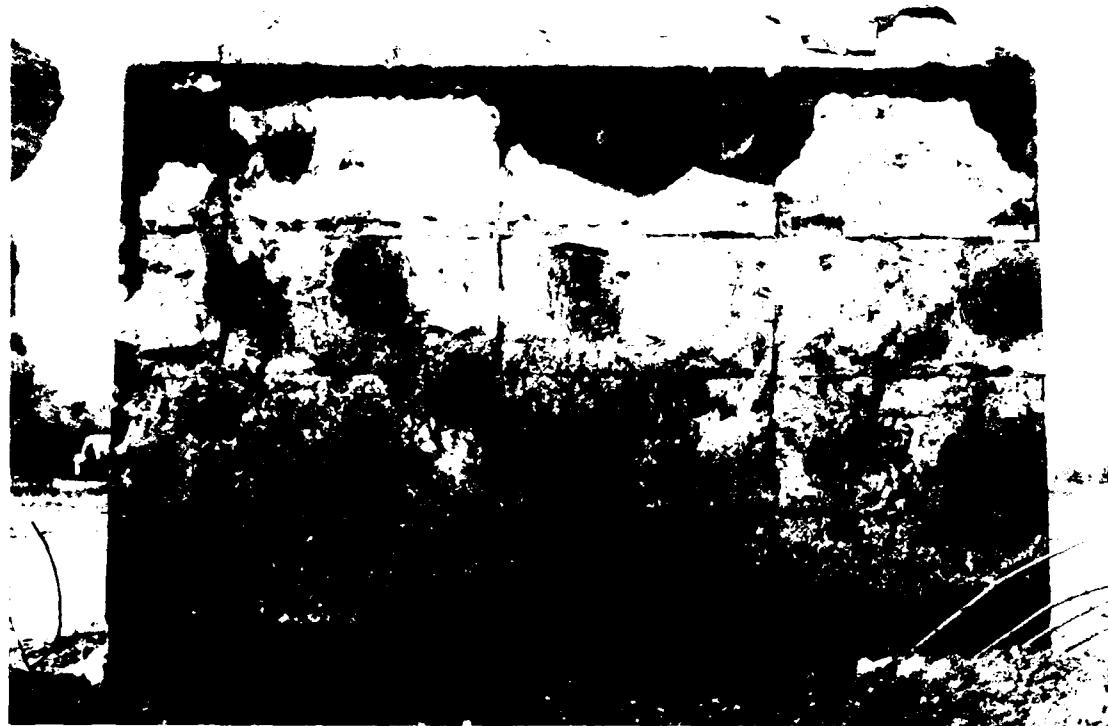
- a. Test 1. The test resulted in no measurable permanent deflection. Some of the existing hairline cracks were widened and a few new cracks formed on the rear of the wall (Figure 11). The front of the wall saw no damage other than some of the existing 4 in. of Styrofoam insulation being blown off, and blackening of the wall surface (Figure 10). There was a noticeable crack formed in both of the side walls (Figure 12a and b).
- b. Test 2. Spalling occurred on both the front and back of the wall. The spall on the front wall was approximately 10 ft wide and 3 ft high at the highest point (Figures 14 and 15); on the rear, it was approximately 6 ft wide and 2 to 3 ft high (Figures 16 and 17). The spall penetrated no deeper than the depth of the inside of the rebars (approximately 4 in.) on both the front and back. There was a 4- to 5-ft-high large crack at the

Figure 10. Blackening of wall from bare TNT explosion

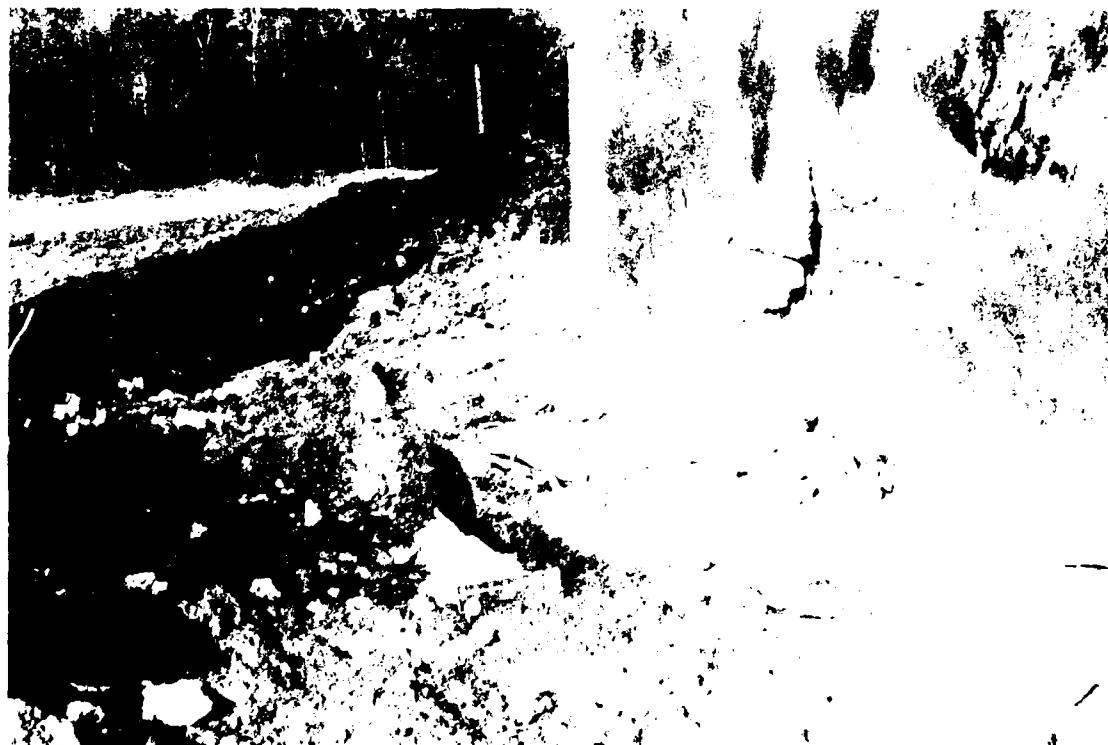
Figure 14. Crater and front wall damage from C-4 detonation

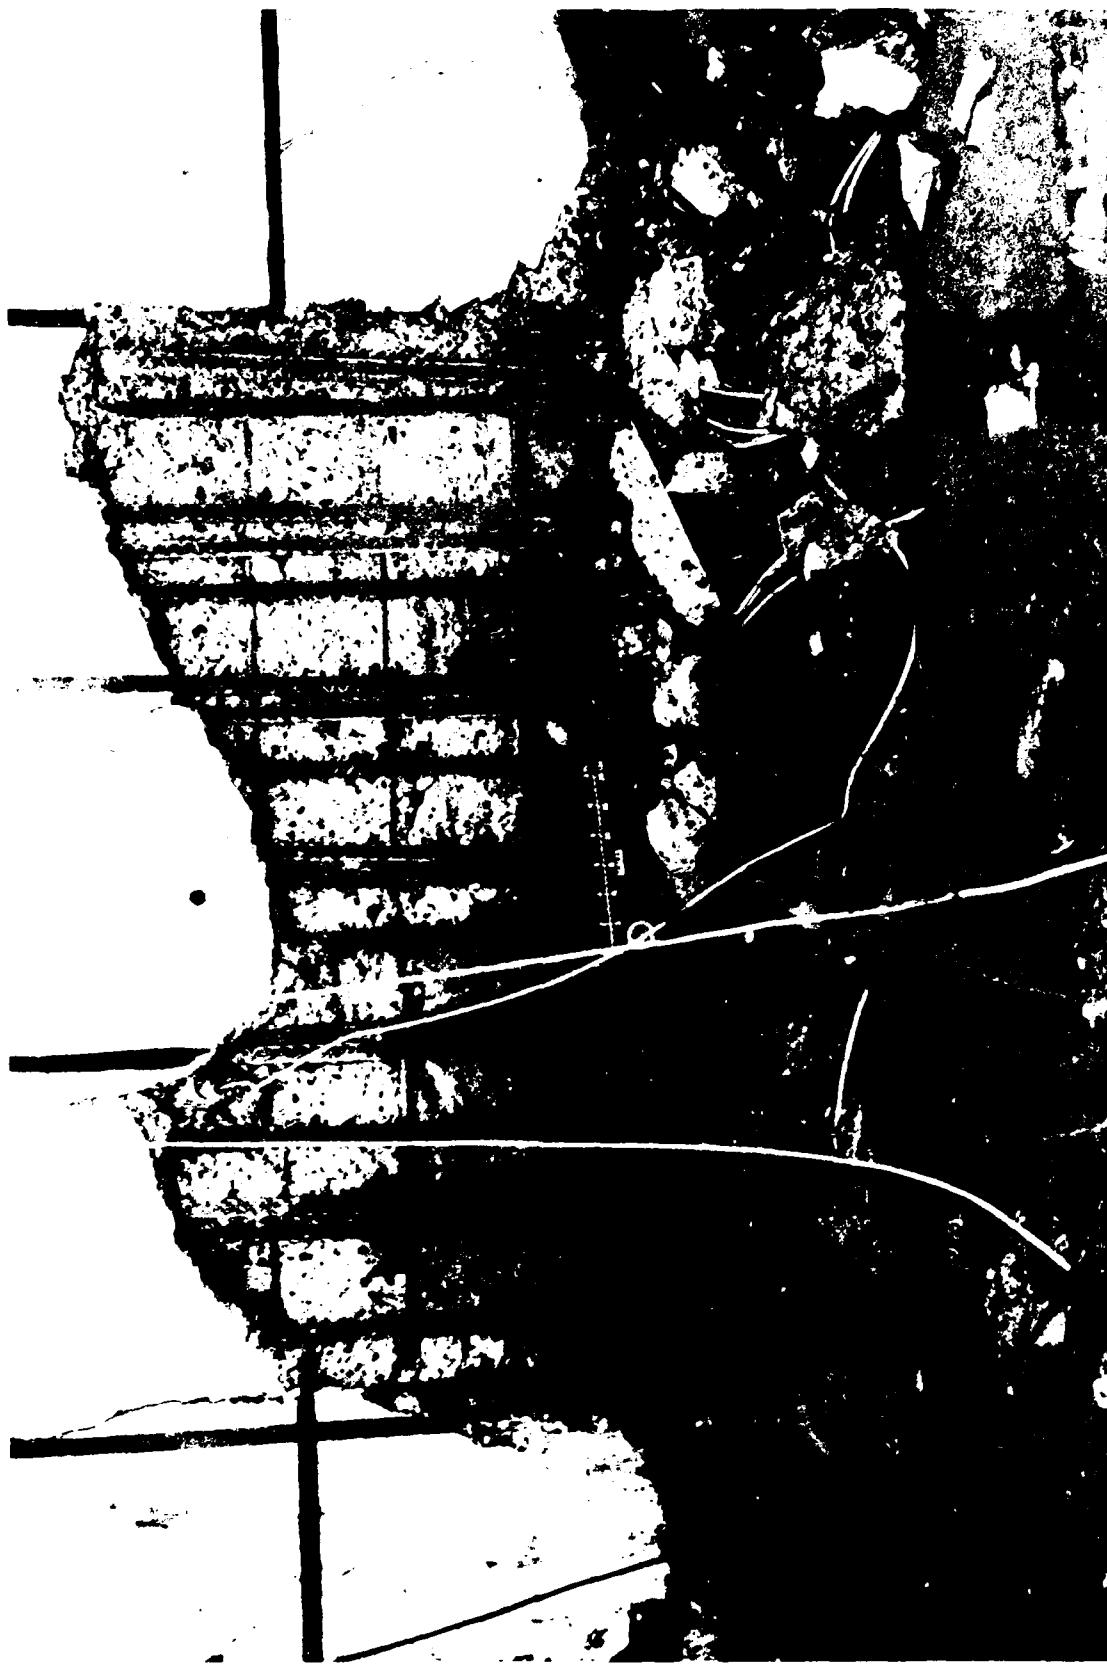
Figure 17. Close-up of spalled area on rear of wall from Test 2

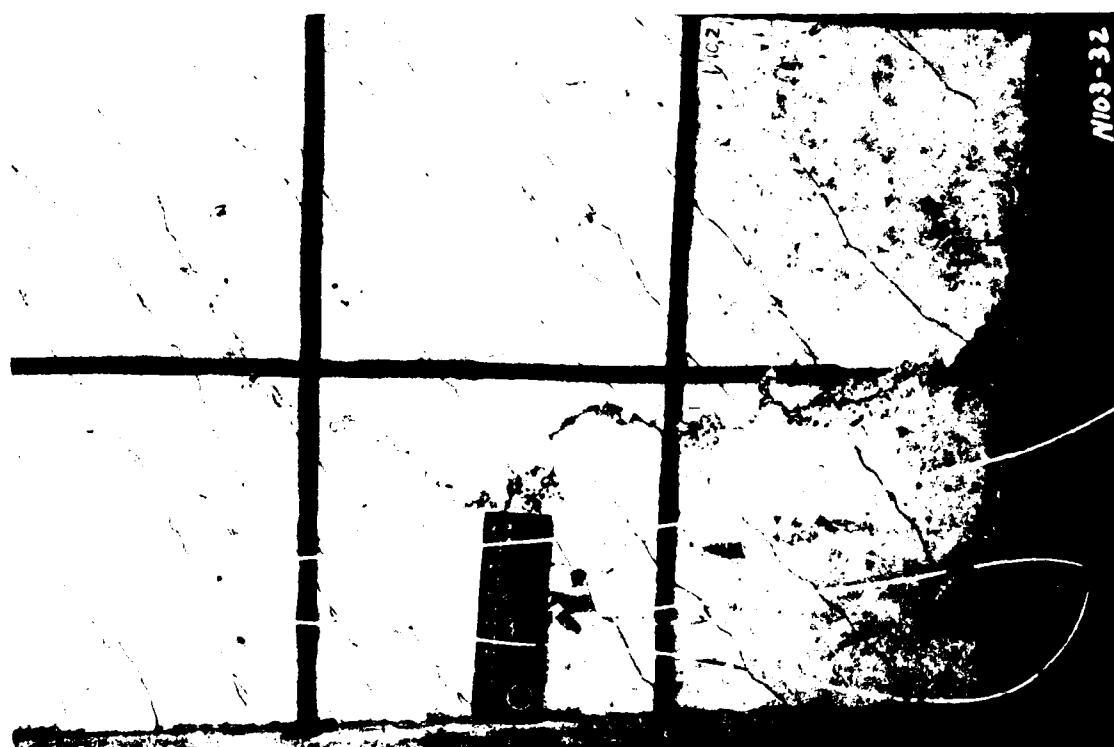
bottom of the wall near both side walls (Figure 18). There was a 2-in. permanent deflection on the No. 8 dowels on the rear face near the bottom of the wall.

Figure 18. Cracks formed near side supports from Test 2

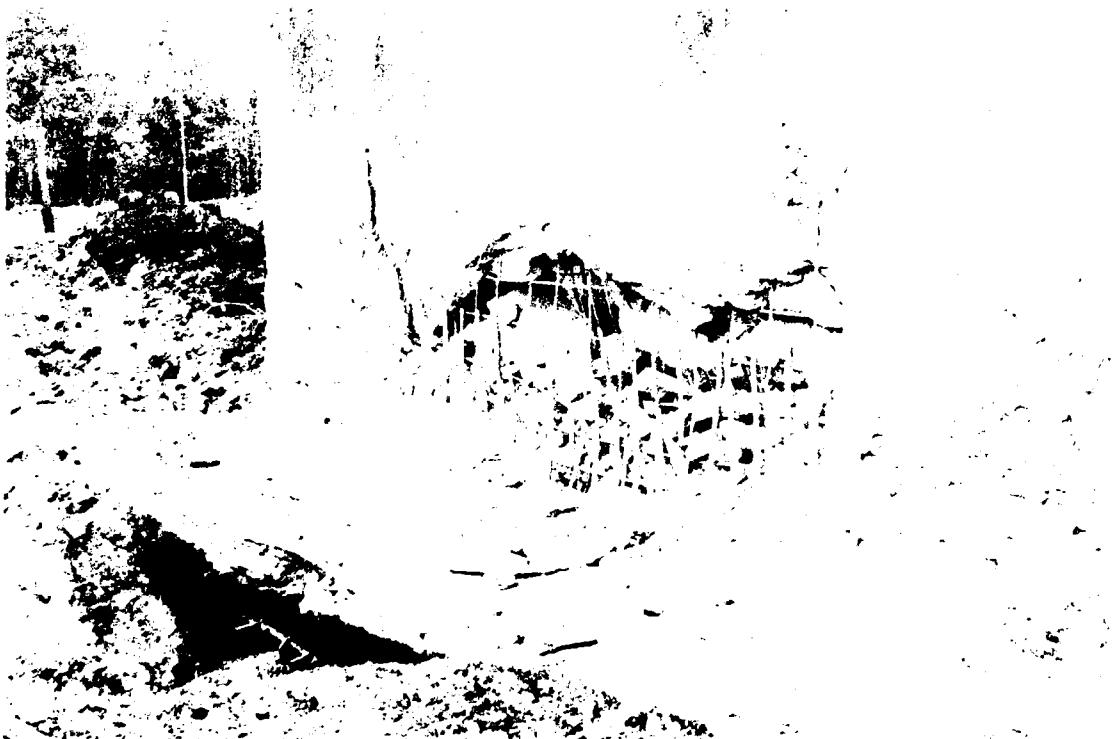
Figure 20. Crater and wall damage from cased TNT detonation

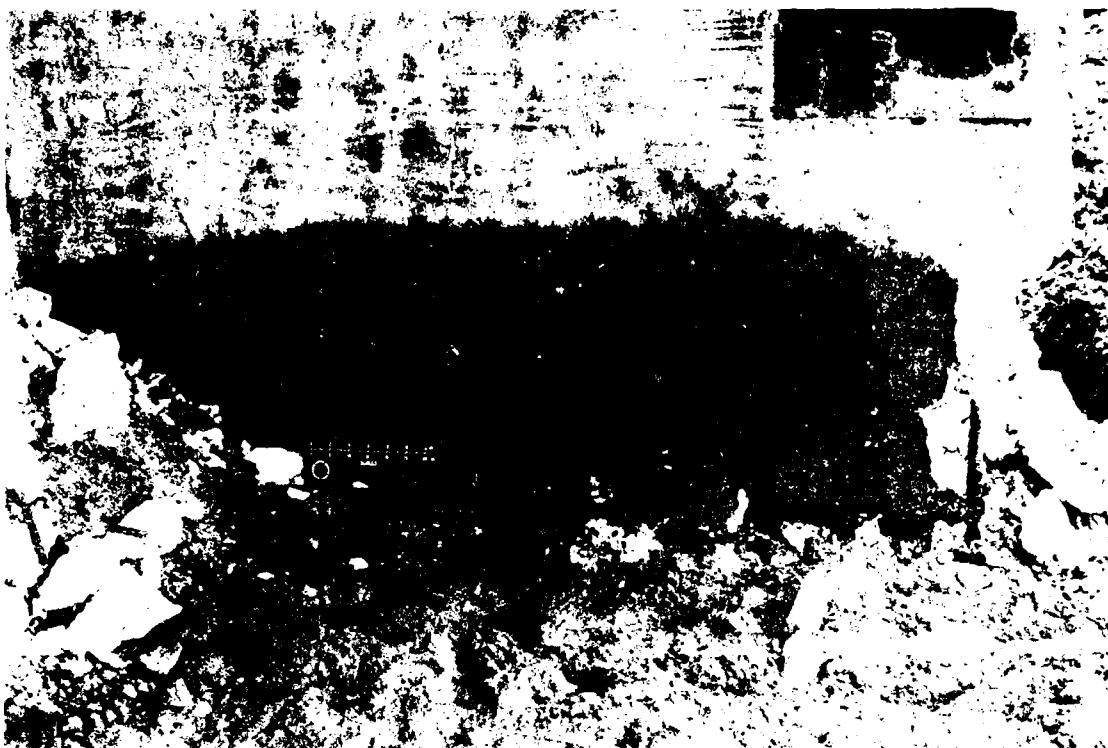
Figure 25. Damage to inside of wall from Test 4

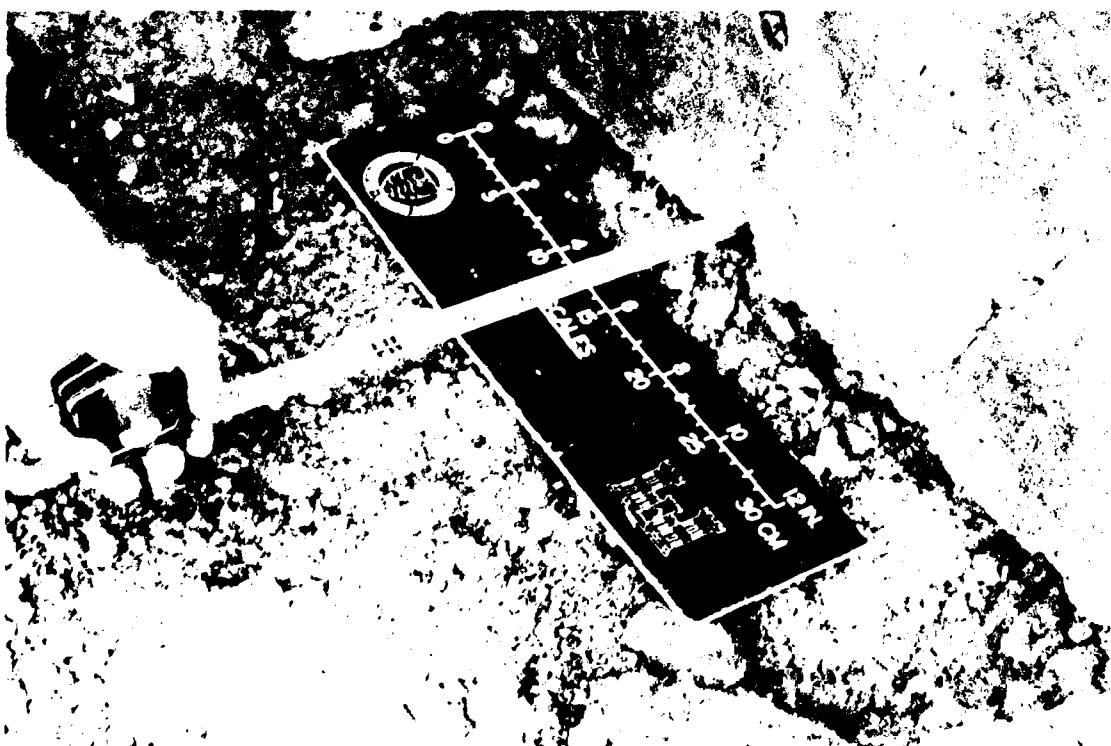
Figure 26. Close-up of bottom of wall showing extent of permanent deflection

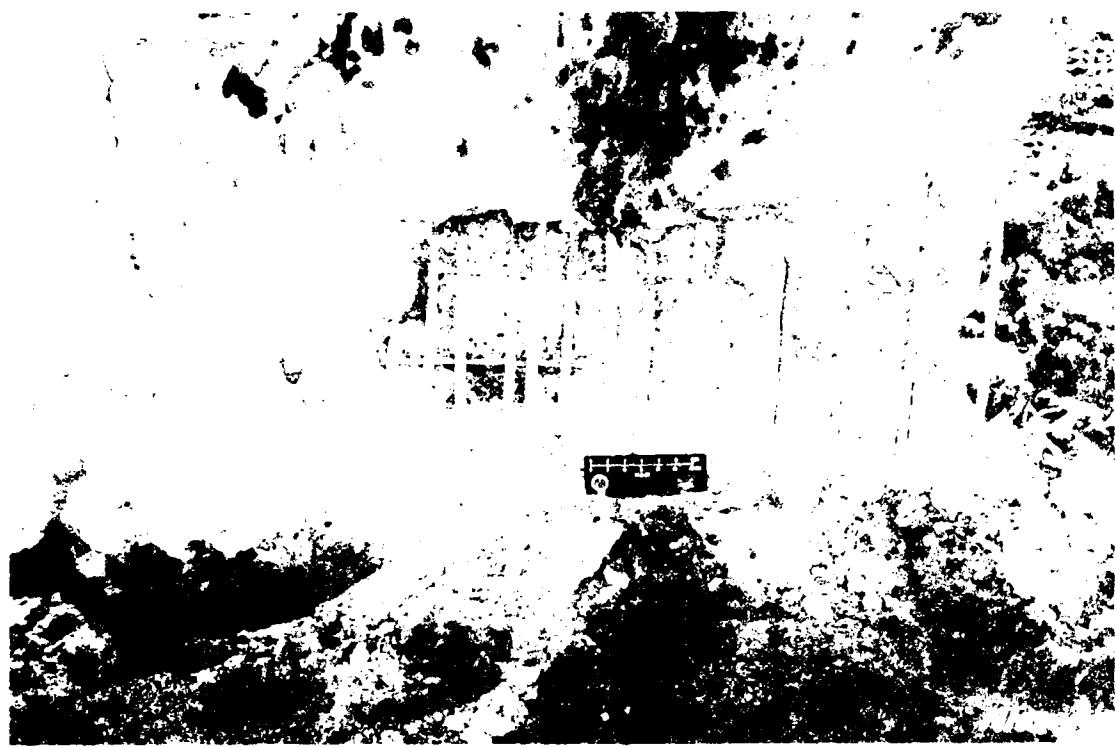
- e. Test 5. The outside of the wall was spalled and cratered by the blast and fragment impact to a depth of approximately 5 in. (Figure 28). The width and height of the area of exposed rebar was 6 by 2.5 ft. Numerous fragment impacts were noted along the bottom of the wall. On the inside of the wall, spalling had exposed the rebar for the entire 9-ft width of the wall and for a height of approximately 3 ft (Figure 29). The ends of the dowels were exposed and bent outward approximately 12 in. from the wall. Near the bottom of the wall the dowels appeared to have a permanent deflection of around 4 in. The concrete was spalled to a depth of approximately 9 in. and the remaining 4 in. of concrete was crushed to the extent that a hole could easily be opened through the wall using a metal rod.

Figure 28. Damage to outside of wall from Test 5
and fragment impact from the cased TNT

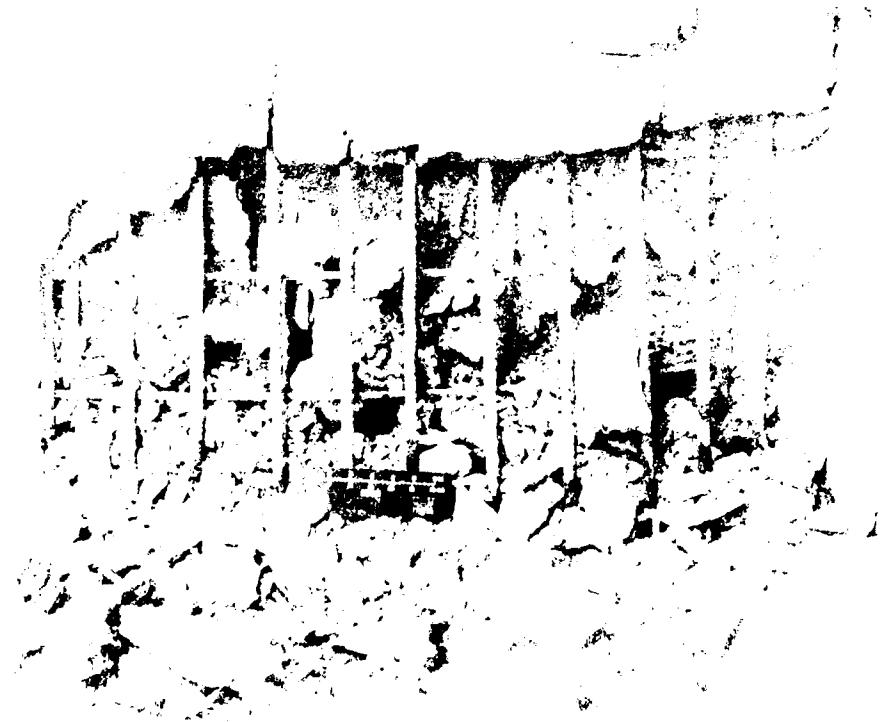
Figure 29. Damage to inside of wall from Test 5
